## TECH SPEC

NUMBER 7

## Repair of Utility Cuts Using Interlocking Concrete Pavers

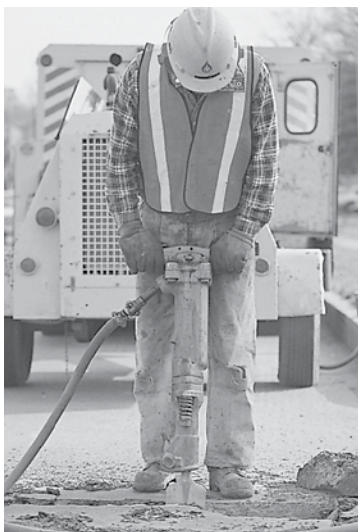
Figure 1. Repairs to utilities are a common sight in cities, incurring costs to cities and taxpayers.

North American cities have thousands of utility cuts made in their streets each year. Figure 1 shows a daily occurrence in most cities: repairs to underground utility lines for water, sewer, gas, electric, steam, phone, fiber-optic, or cable services. A sample is given below of the number of annual utility cuts in a few cities.

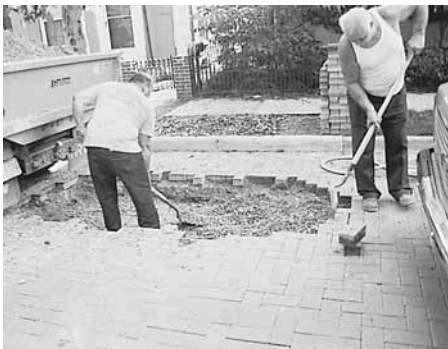
Figure 2. Removal of concrete pavers for a gas line repair in Dayton, Ohio.

Figures 2, 3, 4, 5 and 6 show the process of repair and illustrate the continuity of the paver surface after it is completed. The reinstated units are knitted into existing ones through the interlocking paving pattern and sand filled joints. Besides providing a pavement surface without cuts, the joints distribute loads by shear transfer. The joints allow minor settlement in the pavers caused by discontinuities in the base or soil without cracking.

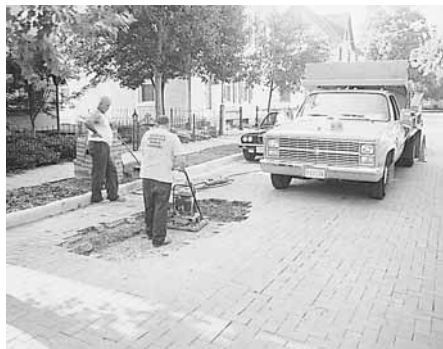
Figure 3. Compaction of the base

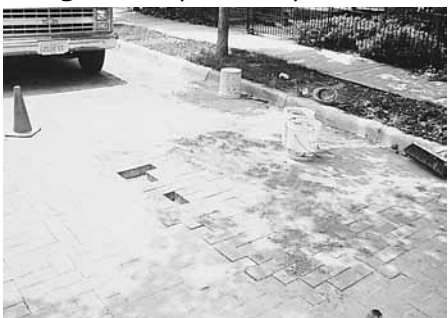
Figure 4. Reinstatement of the pavers, bedding and joint sand

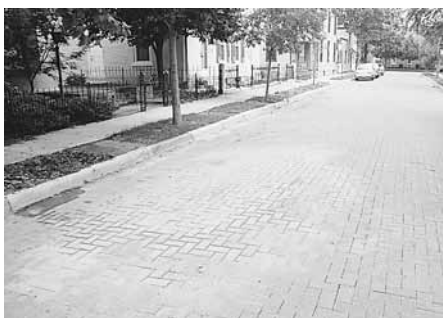
Figure 5. The final paver surface is continuous. There are no cuts or damage to the pavement.

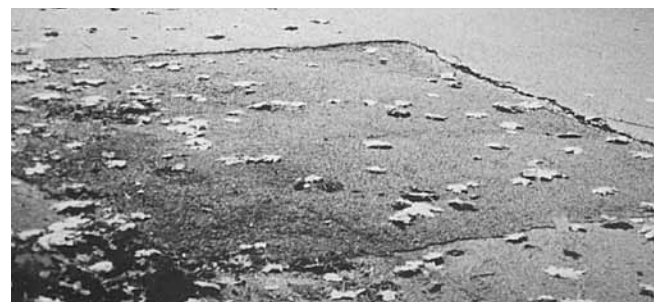
Figure 7. Pavement damage from settlement and shrinkage of cold patch asphalt.

Figure 7 shows the result of settlement and shrinkage of the cold patch asphalt in a London, Ontario, utility cut. The change in dimensions causes the edge of the cut asphalt to deteriorate, and settlement decreases riding quality.

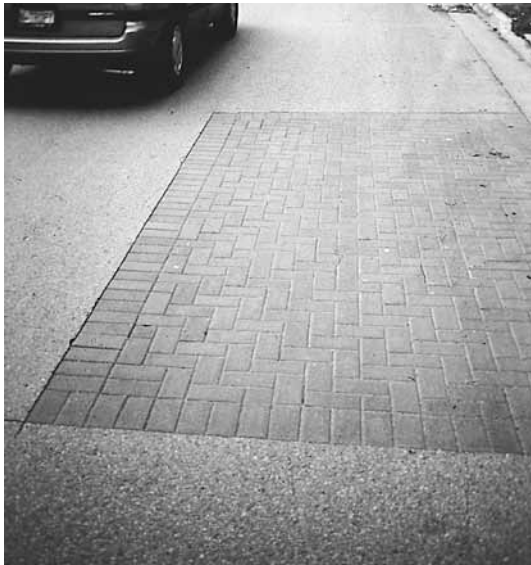
Figure 8. Utility cut repair in a residential area in London, Ontario.

Concrete pavers on low density concrete fill have been successfully used as a replacement for cold patch asphalt (Figures 8 and 9). They were first used as a temporary repair with the intent of being removed in the spring. However, the pavers performed so well that the City of London left them in place indefinitely. Several repairs were in streets subject to heavy truck traffic, as well as residential streets. Costs were less than using cold

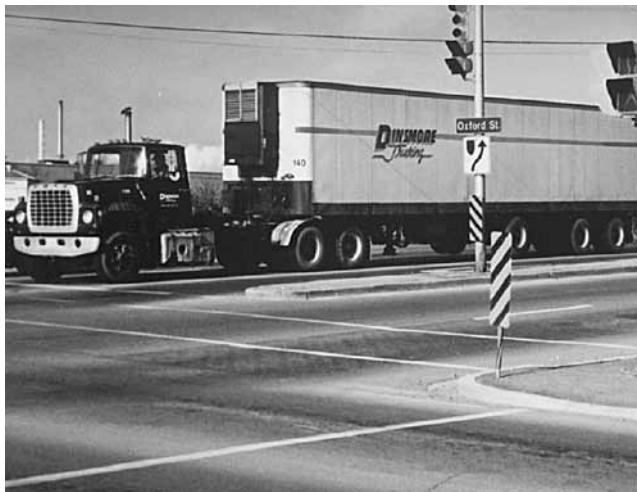
Figure 10. A patch of barely discernable pavers in a heavily trafficked intersection in London, Ontario

All repairs in London with concrete pavers and low-density concrete have produced a smooth surface transition from the asphalt to the pavers. The riding quality and safety has improved to the extent that the transition from one surface to the next can barely be discerned by the driver. The pavers were colored to match the appearance of the asphalt so there would be no substantial differences in appearance. Figure 10 shows such a patch of pavers blending with the surrounding pavement.

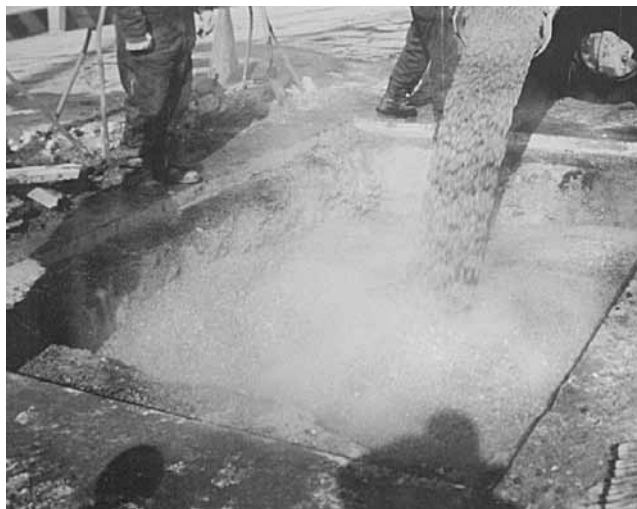
Figure 11. Low density concrete fill (unshrinkable fill) poured into a utility trench from a ready-mix concrete truck.

**Unshrinkable fill** poured into the trench is shown in Figure 11. The fill flows into undercuts, under the edge of the cut asphalt (providing additional support), and in places where the soil or base has fallen from the sides of the trench. These places are normally impossible to fill and compact with aggregate base or backfill material.

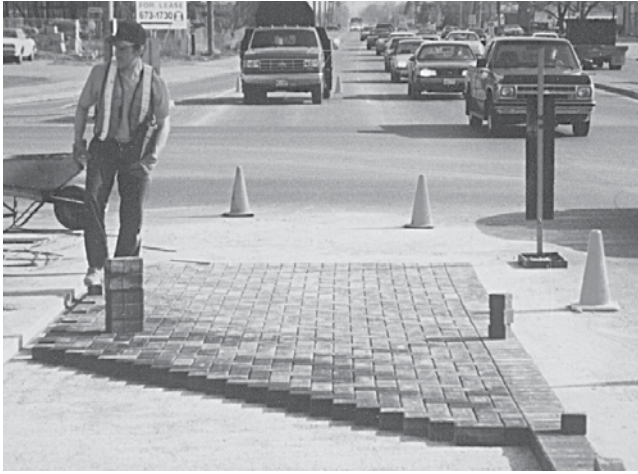
Figure 12. Pavers are laid in a 90 degree herringbone pattern between the border courses.

Place pavers between the border course in a 90 degree herringbone pattern (Figure 12). Joints between pavers should not exceed 1/16 in. (2 mm). Compact the pavers with a minimum 5,000 lbf (22 kN) plate compactor. Make at least two passes with the plate compactor. A small test area of pavers may need to be compacted to check the amount of settlement. The bedding sand thickness should be adjusted in thickness to yield pavers no higher than 1/8 in. (3 mm) above the edge of the asphalt.

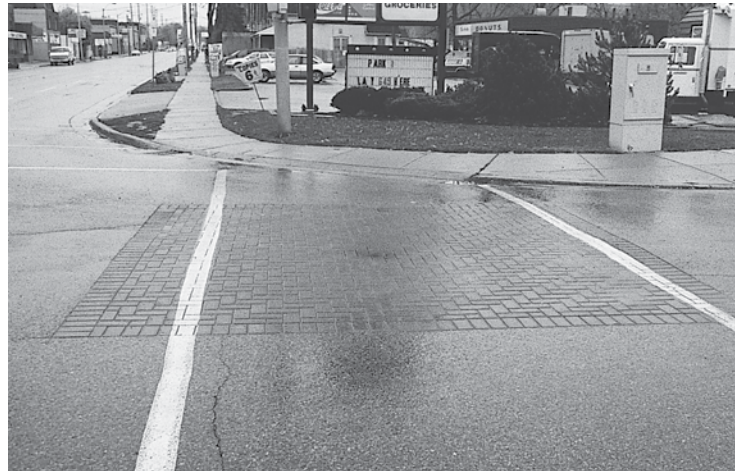
Figure 13. Concrete pavers in utility cuts can be painted as any other pavement.

lane, traffic, or crosswalk markings as any other concrete pavements (Figure 13).
